Epson WorkForce DS-510 Color Document Scanner - clicking sound, multiple page feed broken

There is a jointed shaft that controls multi-page feed operations and one of the joints rounds out. This will show how to either work around it with a staple or repair it with a paperclip. There are no replacement parts available from Epson.

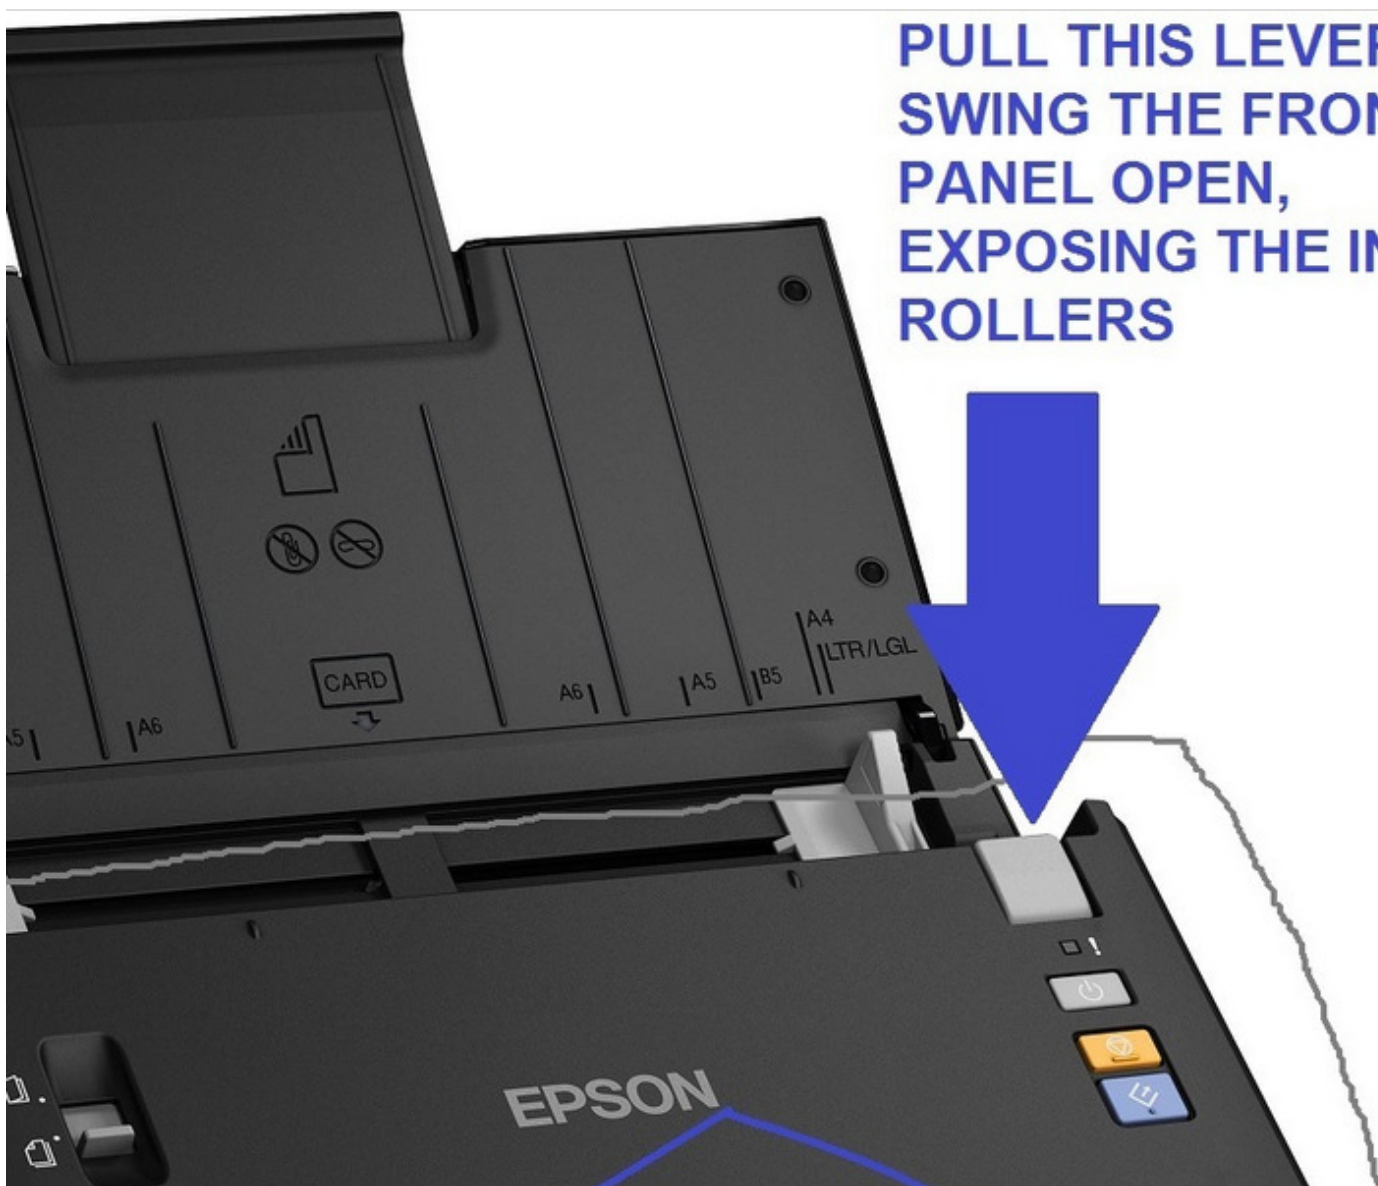
**PULL THIS LEVER TO
SWING THE FRONT
PANEL OPEN,
EXPOSING THE INSIDE
ROLLERS**

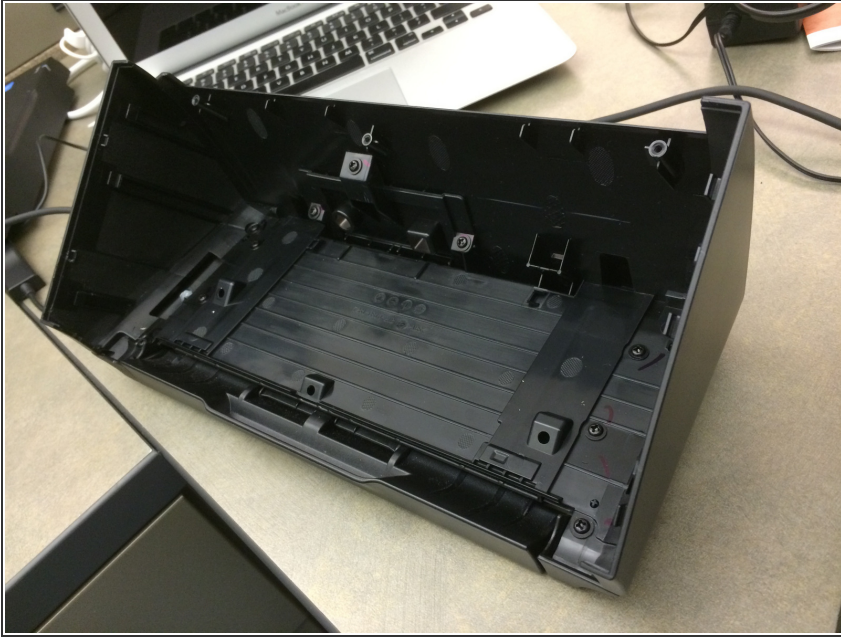
Step 6

- Once that's accomplished you pull the main body of the scanner OUT of its wraparound shell (back, bottom and sides), using a small pry tool to help pop the shell loose around the edges. It's tough plastic so you probably won't break anything, and it's mostly hollow too so don't worry about where the screwdriver goes inside of it while you're prying
- Seen here is the shell once the "guts" are out of it.

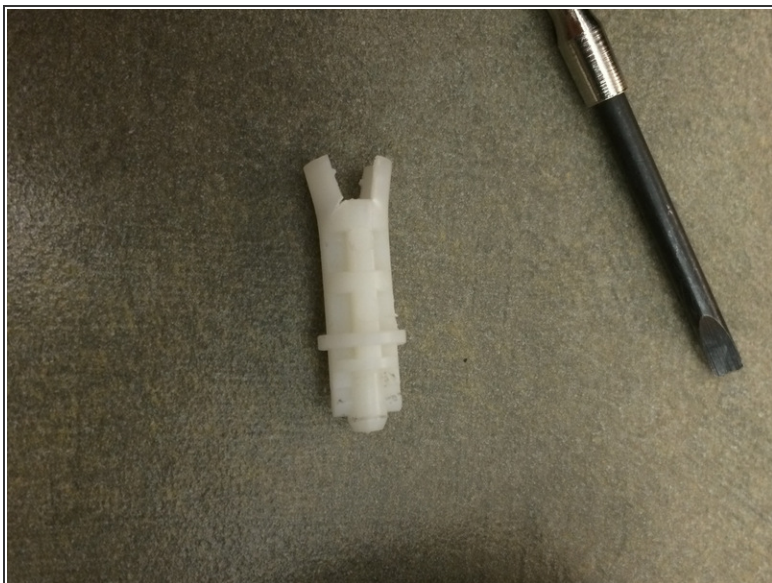
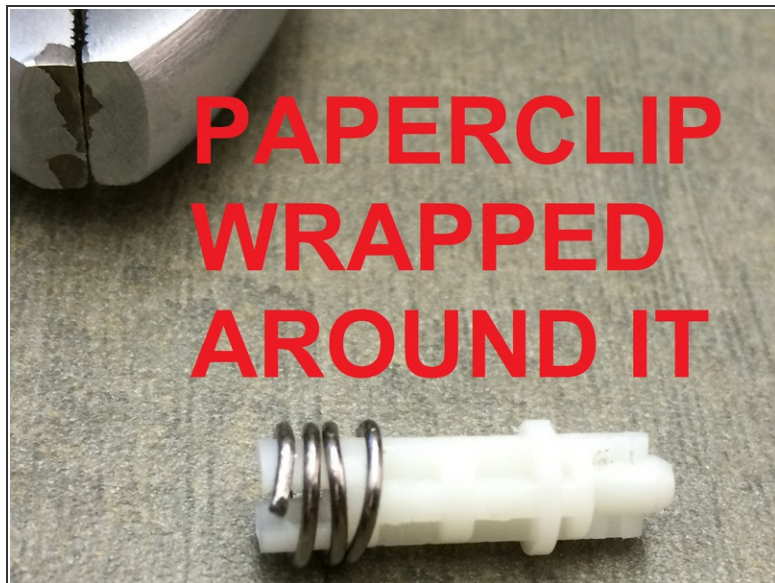
Step 12

THE PROBLEM: In the front section that you pull up on the gray lever to allow to swivel out about 30 degrees --it's the section that says Epson on the front and has the lights-- a piece went bad in there. Here's the gist-- in order to pull just one sheet at a time, the rollers in the front panel must not move until the last sheet; they provide friction as the scanner pulls the sheets underneath out. What's happened is that one piece that's supposed to hold the roller from moving has failed and the roller now rolls and therefore the whole stack comes through. A small plastic shaft has tabs that have become splayed on one end and won't hold the rollers in place.

- Using the pliers, tightly wrap a paperclip around the shaft you have removed. Wrap it near the end that is NOT splayed out, then pull it up to the end which IS bad, as you move it up, it will squeeze the splayed ends back in place.
